Hudson River Estuary Watershed Assessment & Outreach Project

2007 Watershed Report Card for the Rondout Creek

A Hudson Basin River Watch Watershed Assessment & Outreach Project

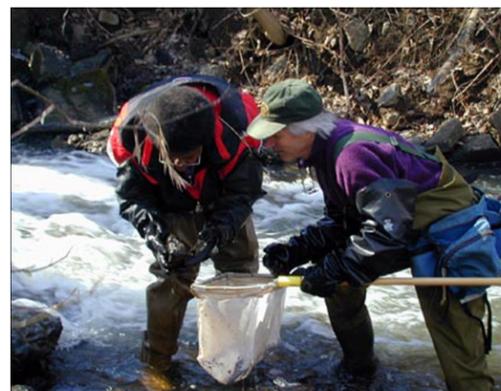
The NYS DEC Stream Biomonitoring Unit's (DEC SBU) methodology was used for all sample collection and analysis tasks. These methods involve collecting, sorting and analyzing a sample of benthic macroinvertebrates - stream bottom-dwelling organisms with no backbone that are visible to the naked eye. These organisms vary in their sensitivity to water quality impacts. DEC SBU's methods use the presence or absence, relative abundance, and diversity of species to obtain an overall water quality score called the Biological Assessment Profile (BAP). BAP is scored 0-10, with 10 indicating the best water quality. The DEC SBU also uses four narrative descriptions of water quality based on the BAP score as illustrated in the graph below:

It's important to note that the term "slightly impacted" can be misleading if it's taken out of context. Sites with water quality at only 5.1 on the BAP scale, or almost "moderately impacted", can be described as only "slightly impacted".

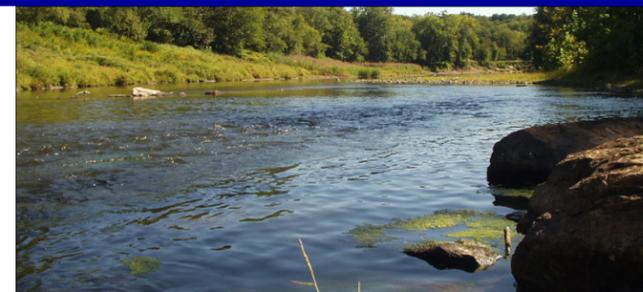
Rondout Creek Site RN14, in the Town of Rosendale

Station RN14, Rondout Creek, is just downstream of the Rosendale sewage treatment plant, in the Town of Rosendale. The BAP score of 6.20 fell into the slightly impacted category. The ISD indicated a community structure affected by non-point source nutrient additions.

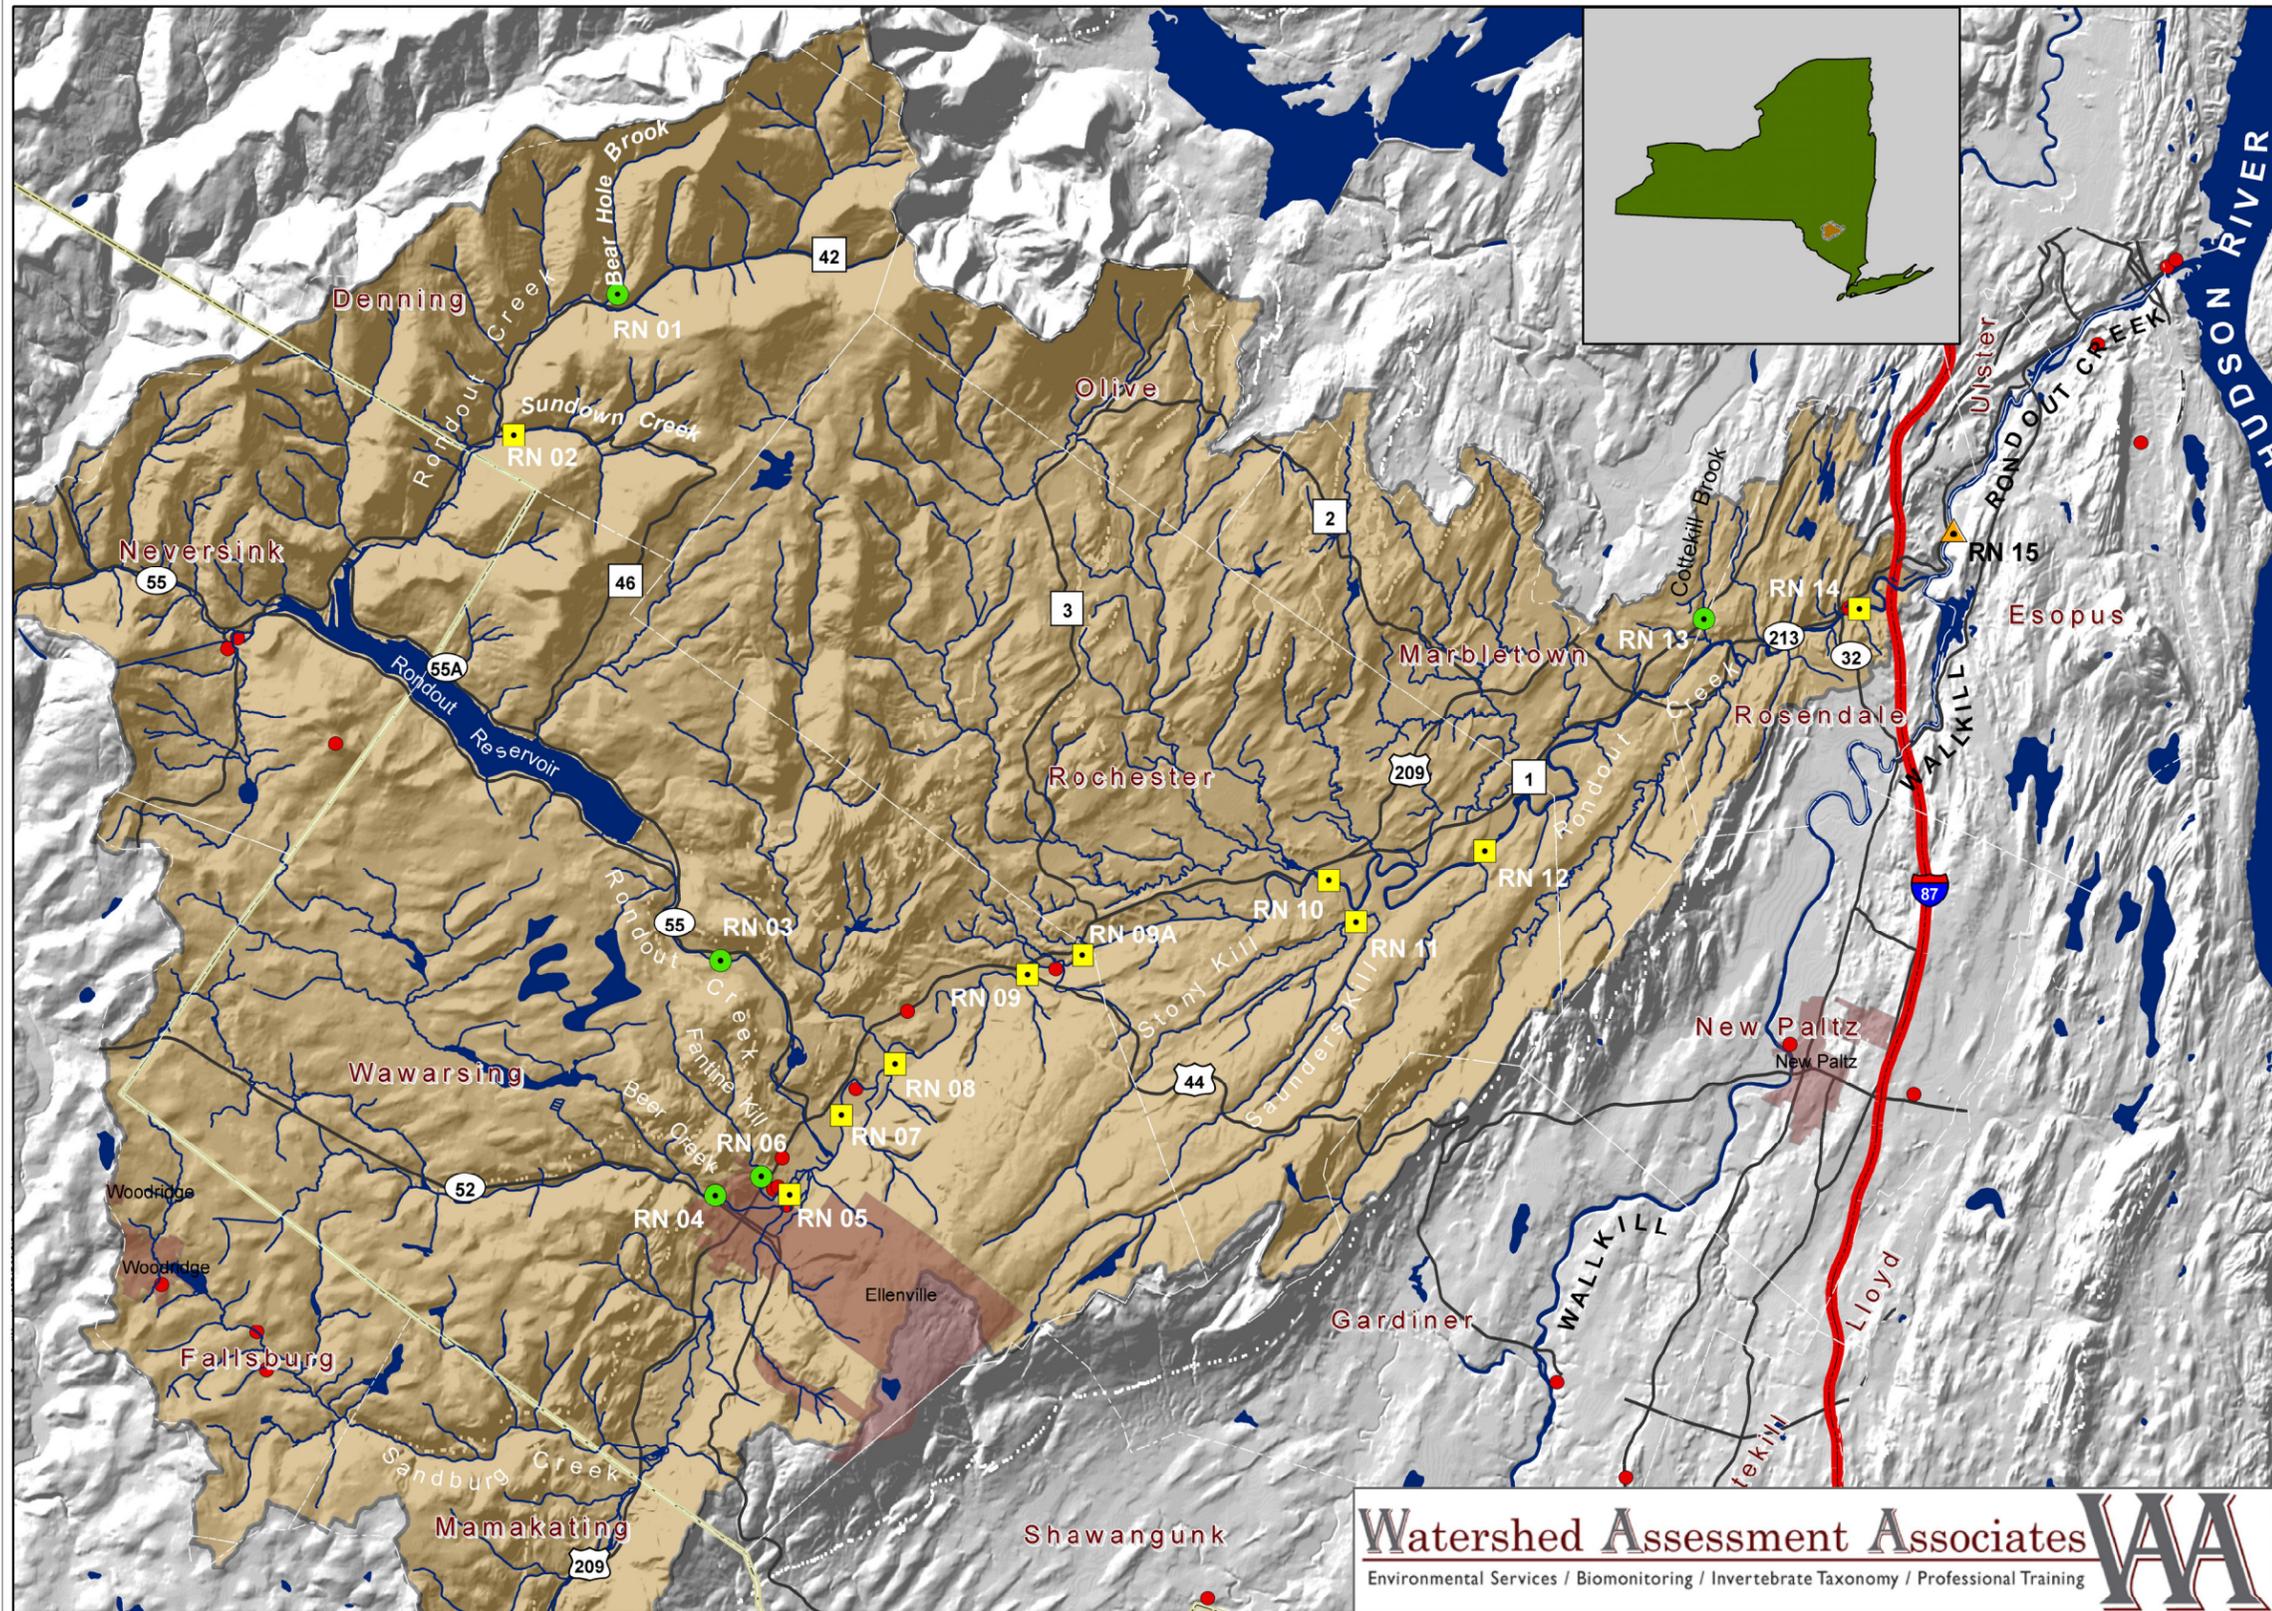
Figure 1
Rondout Creek
2007 Biomonitoring Study
Base Map

Water quality was non-impacted at 5 sites, slightly impacted at 10 sites and moderately impacted at one site. Of the 5 non-impacted sites, only one was on the Rondout Creek, the first site below the Rondout Reservoir. The other 4 non-impacted sites were tributaries draining relatively undeveloped areas. "Non-point source nutrient additions" was the most common source of impact, appearing in 12 sites. "Sewage effluent and/or animal wastes" appeared in 3 sites, and "Complex sources" (municipal and industrial inputs) appeared in 3 sites. The one moderately impacted site is located downstream from the confluence with the Wallkill River and is also affected by large changes in flow from a hydroelectric dam. More information on methods, terminology, and data interpretation is on page 4.

Source:
NYS GIS Clearinghouse and CUGIR;
Sampling locations were assessed
by Hudson Basin River Watch
GIS mapping and taxonomy services
provided by WAA
